ICON: Minimally Invasive Treatment with Maximal Results

Written by Dr. Peter Auster | February 2019

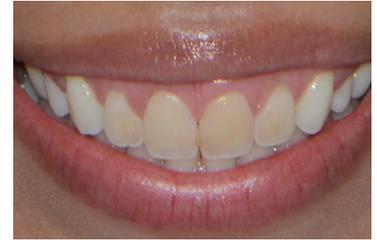
Figure 1: Preop smile

The patient, a 28 year-old female appeared in our office with dark yellow stains from teeth 7-10 (figure 1). Teeth numbers 8 and 9 were grossly stained. 7 and 10 showed less volume of stain but the color was equally yellow. All other teeth were a beautiful light shade in the whitening shade range. The surface texture of the stained areas was odd- a rough scratchy surface that felt different than healthy enamel (figure 2). The patient had no obvious decay, no discomfort, and only a few small restorations. The lingual enamel was healthy- no sign of bulimia. A dental history revealed that the patient had a lemon sucking habit for many years. She would place a piece of cut lemon between her upper teeth and lips and leave it there until the flavor disappeared.

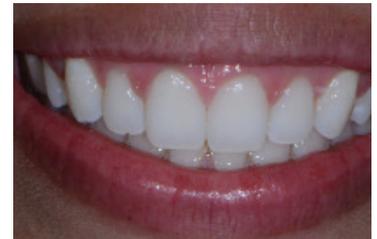
Figure 6: Final

The treatment for the patient with lemon erosion damage was clearly successful and one could say, life changing. (figure 6) It is now a year later and the stain has not returned at all. The author has not seen a comparable product on the dental market that treats mild to severe stains without a far more invasive and expensive approach (full facial bonds or veneers). We have seen great success in post-orthodontic decalcification as well.

Once the tooth is desiccated, the infiltration procedure can take place. Icon Infiltrant (the resin matrix) is applied with the operatory direct light turned off. The infiltrant is applied for 3 minutes to allow full penetration of the surface. This material is continuously placed to insure that the surface remains wetted for the full 3 minutes. (This can be increased to 5 minutes in complicated lesions). Excess material can be removed with cotton pellets. The contacts are flossed and the teeth are each light cured for 40 seconds. At this point the rubber dam or paint on dam/Optragate are removed.(figure 5) The restoration is now treated like a composite restoration and polished with polishing cups and discs.
