Post-Orthodontic White Spots Treatment with Icon

Written by Dr. Chad Duplantis | February 2019

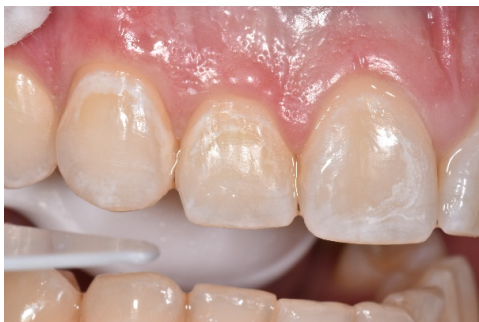
This patient has been a patient in our practice for several years and has always been concerned about “white spots” on his maxillary anteriors. He has been out of orthodontic treatment for 6 years, and the white spots have been present since de-bonding the brackets. The patient’s hygiene has been meticulous post orthodontics. He had been asking for a “minimally invasive” way to remove the white spots.

PRE ICON TREATMENT

1. A gingival barrier was placed to isolate the teeth and protect the gingival tissue, after which, the teeth were etched for 2 minutes, suctioned off and rinsed for 30 seconds.
2. The area was visualized utilizing Icon-dry and re-etched two additional times for two minutes each to achieve optimal results.
3. Following a highly satisfactory visual inspection, the Icon infiltrant was placed for 3 minutes and, after removing the excess via cotton pellet, cured for 40 seconds.

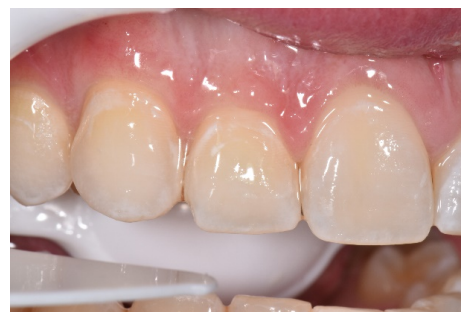
The patient was thrilled with the results. He expressed minimal discomfort throughout the procedure and was not sensitive to air or water immediately following the procedure.

POST ICON TREATMENT
